Manhole Inspection Summary

Manhole # S45UU_022MH

Insp Date: **3/30/07 9:37 AM**

Location Address: **2831 HILLEN RD**

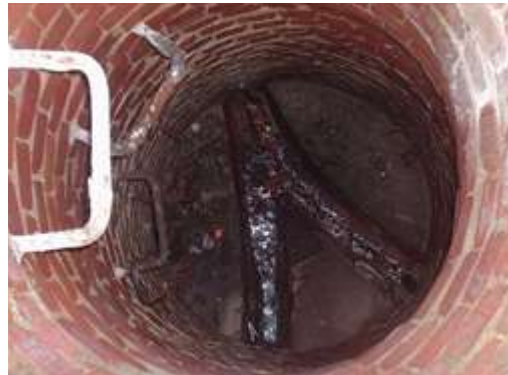
Top View

Barrel infiltration. Corroded steps.
Evidence of surcharge - Bench debris.
Channel debris.

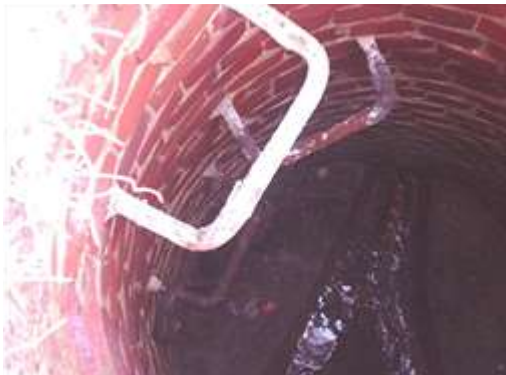
Defect

Infiltration: ☐ None ☐ Joint ☐ Cracks ☐ Mortar ☐ Roots ☒ **Wall**

Barrel infiltration.

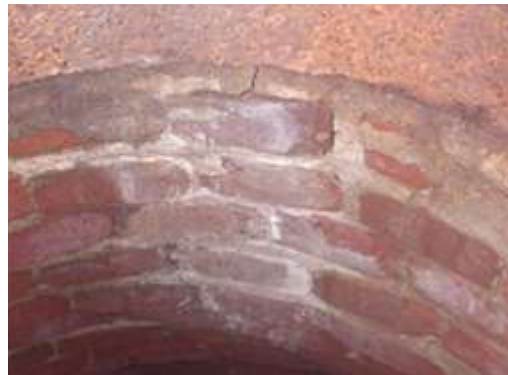
Defect

Infiltration: ☐ None ☒ **Joint** ☐ Cracks ☐ Mortar ☐ Roots ☒ **Wall**

Adjustment infiltration.

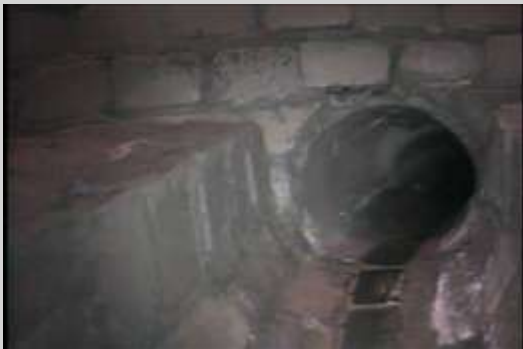
8 in. Circular Gravity Sewer Pipe In @ 4 O'Clock

Infiltration: **Evidence** Pipe Seal Cond: **Unknown**

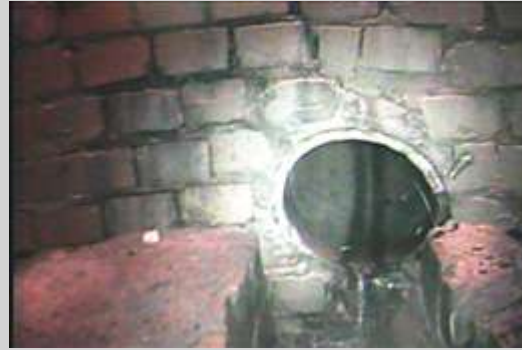
Drop In @ 7 O'Clock

Barrel deterioration and infiltration.
